Condition Assessment of Excedra [Curved Bench] at Deerpath Road

By Rommy Lopat
To Lake Forest Library Board
October 11, 2022

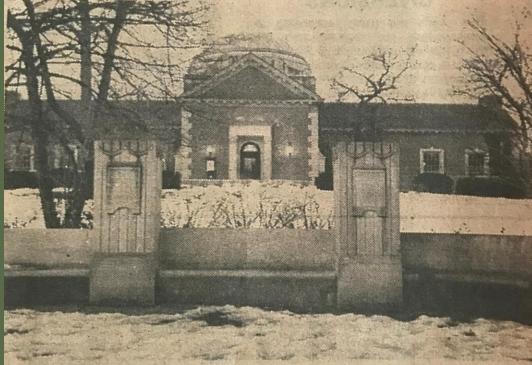
The Lake Forest Library at 360 E. Deerpath was constructed in 1931. The riginal landmark structure is topped with a lead-coated copper dome bove the book circulation area. (File photo)

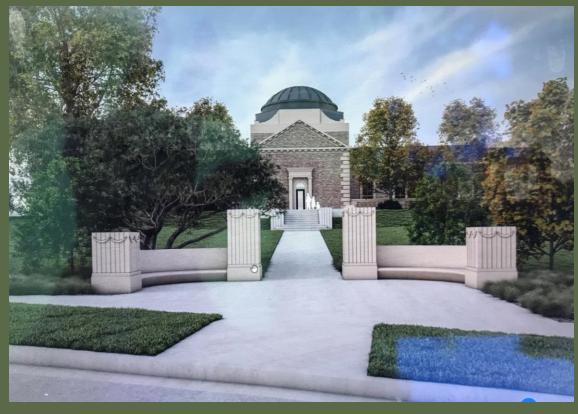
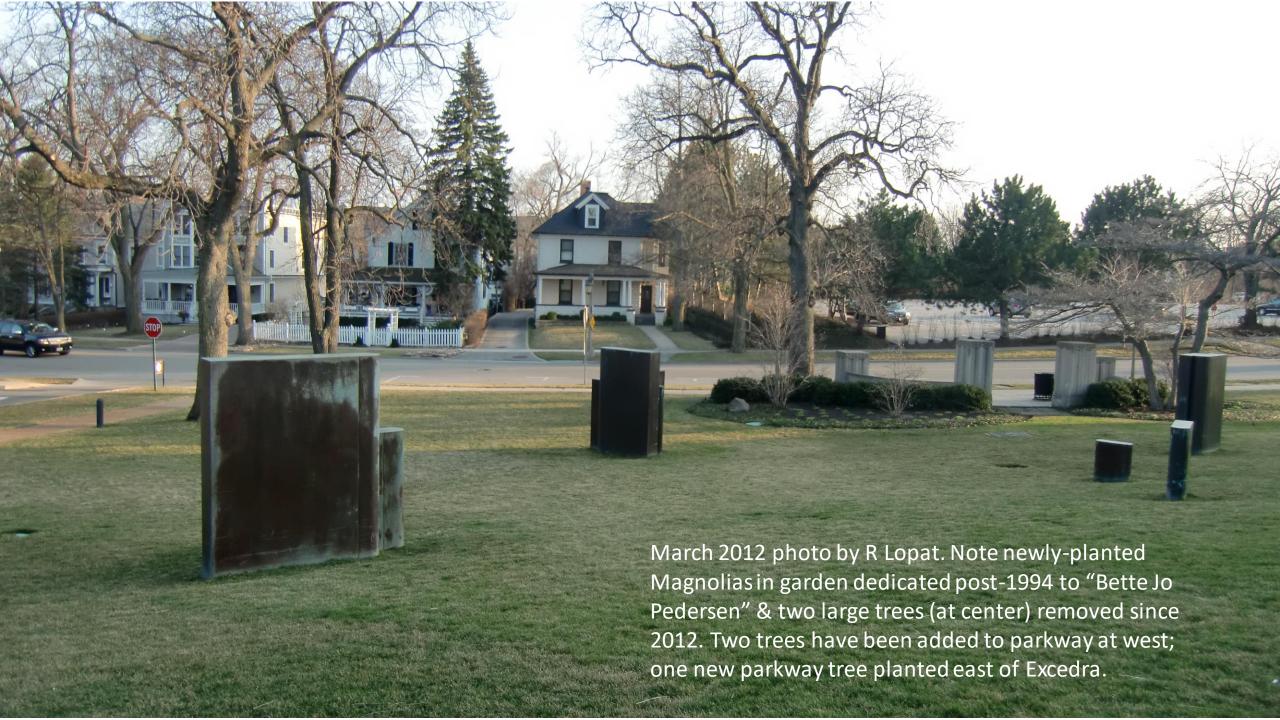
OVERALL VIEW OF LIBRARY

- Building and Dome no longer visible due to Hawthorn branches
- Visual clutter in view (ie 3 pieces of Croydon sculpture; Lannon stone steps and irregular steppers; sculpture and hosta at front door)
- Colorful flowerpots obscure classic architectural pillars (Plaques say "The Lake Forest Library")
- Excedra is 3-4' off center

- Limb up and thin Hawthorn; thin Magnolias
- Move trash receptacle to west sidewalk
- Move flower pots to outer pillars
- Remove yew bushes behind Excedra (needs discussion)
- Clean limestone / concrete with D2 Cleaner (after consultation) or powerwash

- Relocate Croydon "books" outside of view
- Hire preservation architect to assess pillar foundations; map alignment / topography of Excedra to front door; provide estimates of fixing foundations and masonry
- Hire landscape company to design improved gardens; reconfigure terrace and center steps; assess symmetry of vegetation; offer options for hillside treatment to front door.
- Undertake Landscape Analysis of entire property. Set goals.

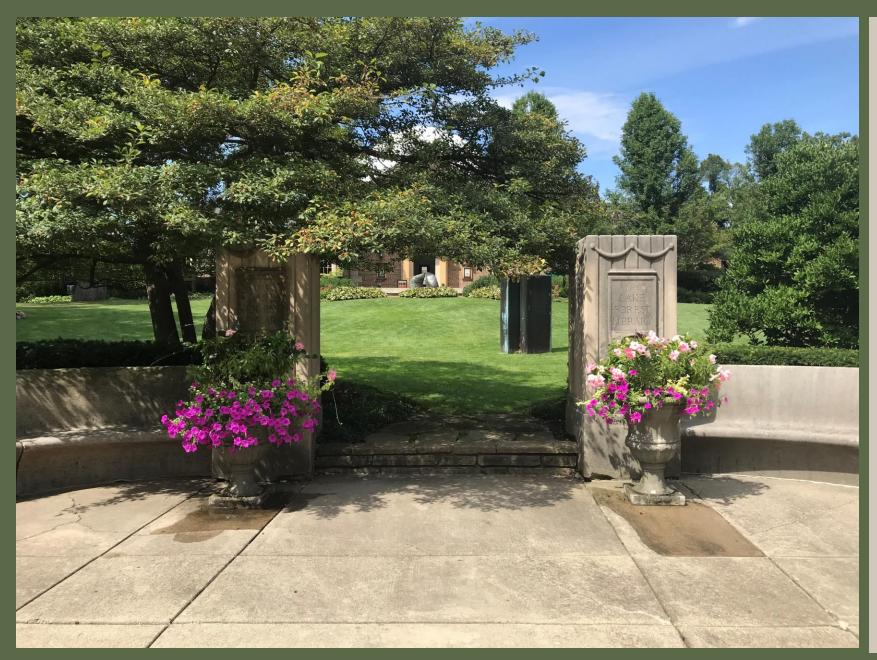
Think like a photographer...or a visiting pedestrian. What do you see?

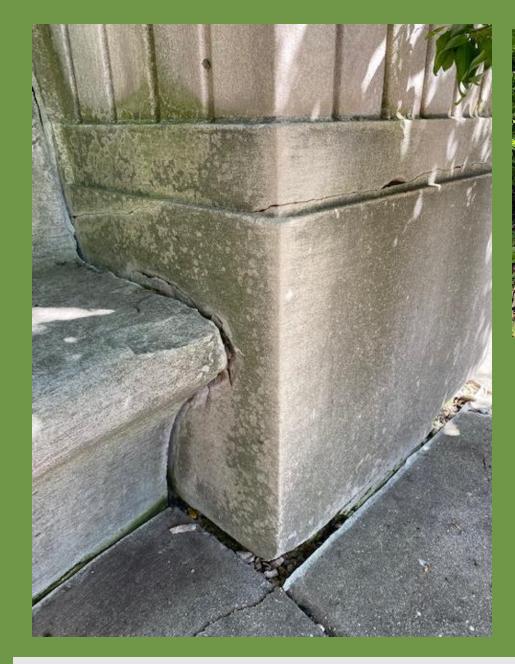
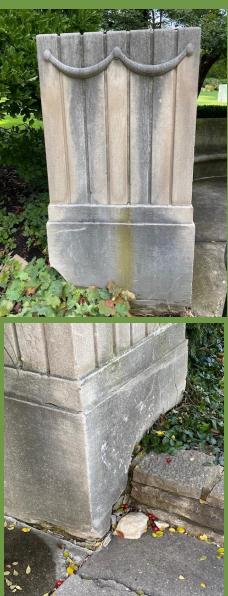
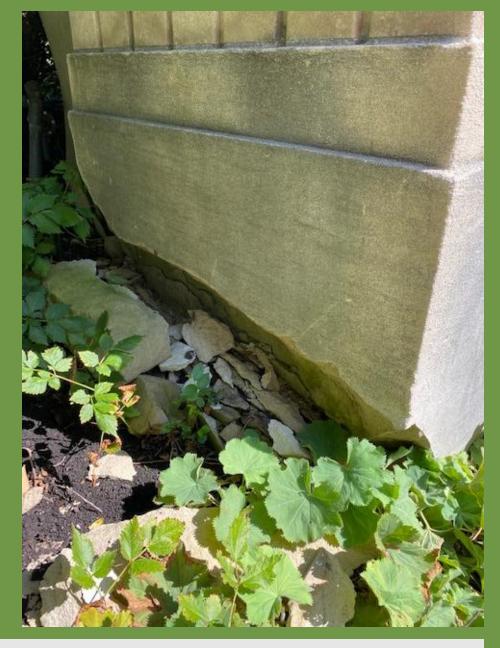
DISCOLORATION + DETERIORATION OF LIMESTONE BASES ON 3 OUT OF 4 PILLARS DUE TO STORMWATER EROSION

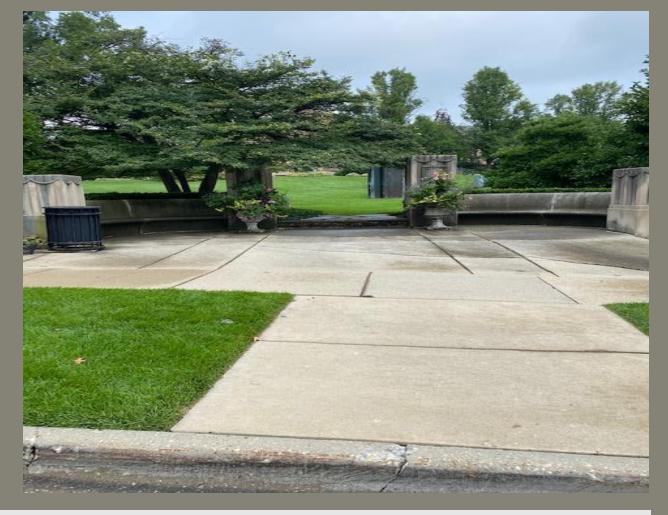
Lots of expansion joint lines going in all different directions in the view above. At right, the sidewalk to nowhere—leads to Deerpath but mostly to the berm across the street.

Remove / relocate extraneous elements (ie expansion joints; flower pots) from the picture OR add visual diversions (Create central medallion in terrace? Use one large-scale flowerpot in center?)

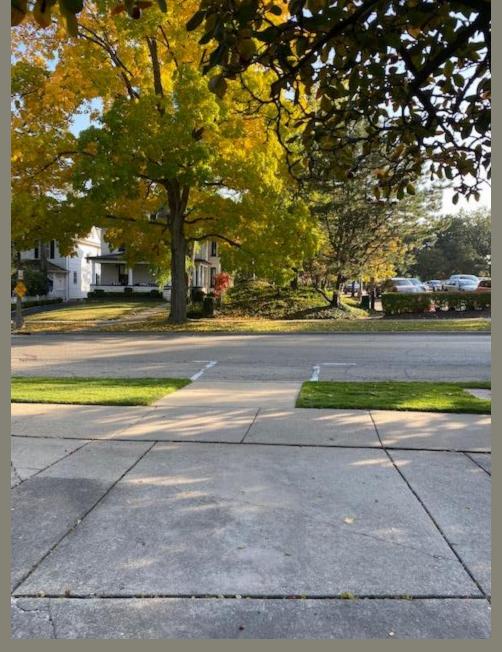
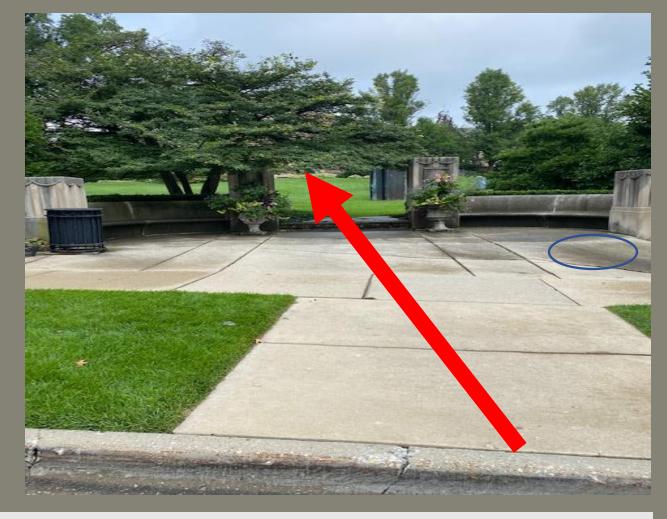
Where is the centerline? How do we align (or fool the eye) the sidewalk, the entrance posts, and the Library's front door? Sidewalk leads to...nowhere.

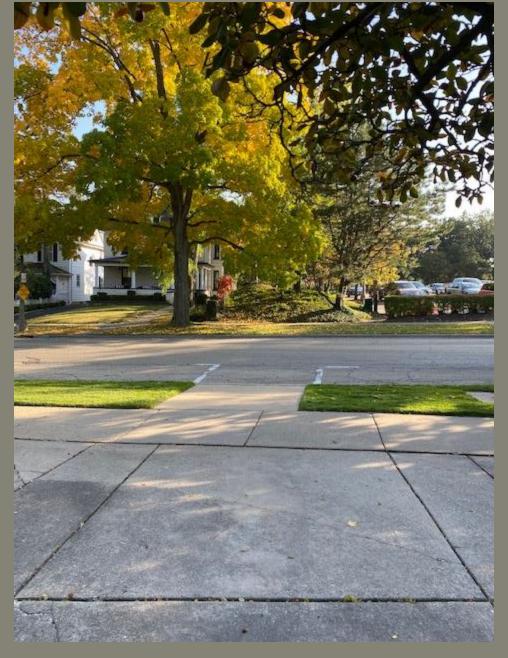
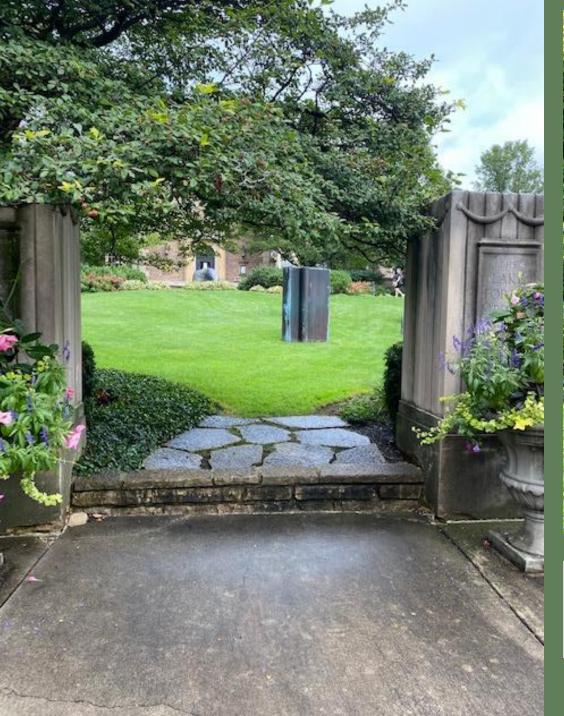
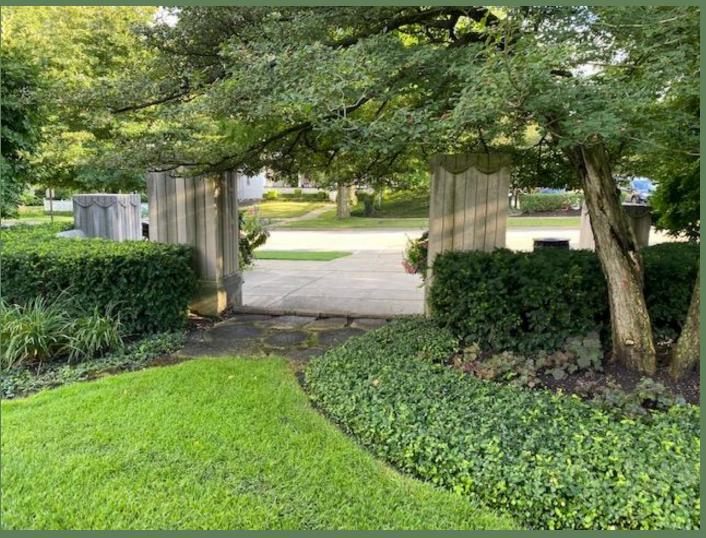
LAND- AND HARD-SCAPE REQUIRE REBALANCING
Re-contour of beds, pruning of low branches, removal of yews,
addition of large-scale limestone steps to match architecture
