## SECTION 00 91 02

### ADDENDUM 2

Project  
**Lake Forest Library Dome Roof Replacement**  
360 Deerpath Road, Lake Forest, IL 60045

**Batten Profile**

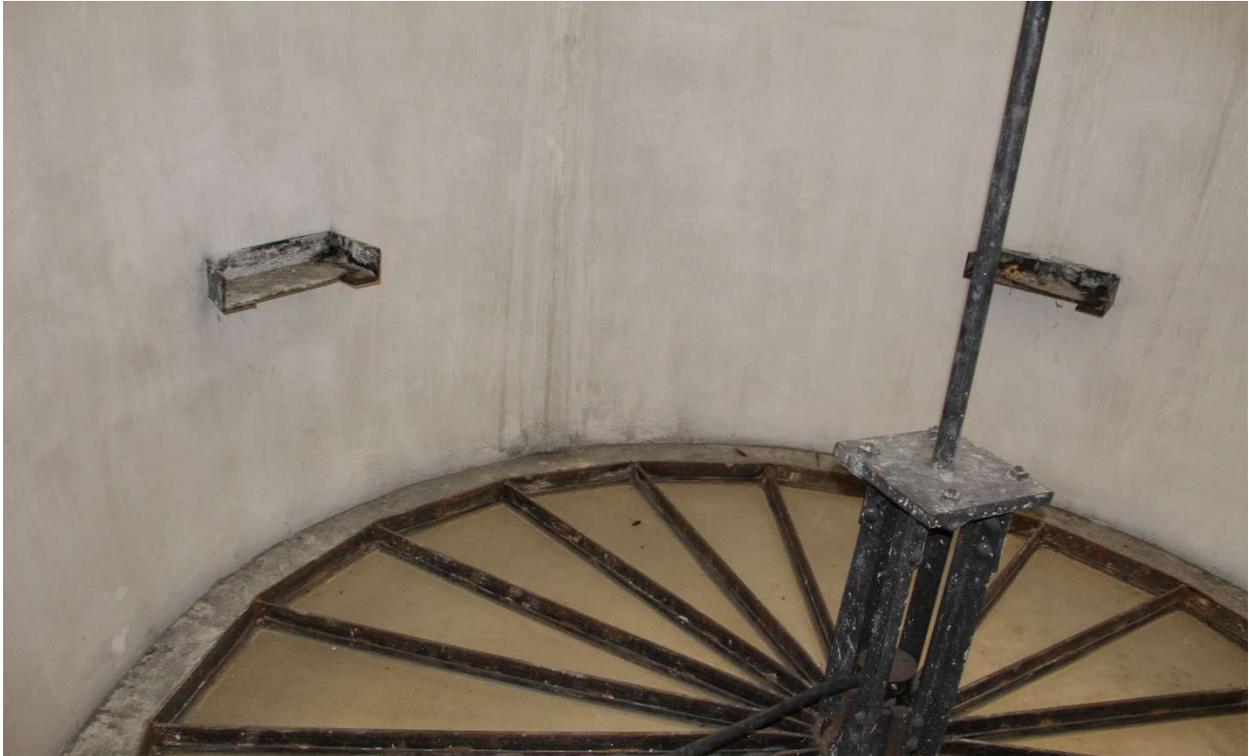
Figure 1. Wall brackets and central hub above laylight.

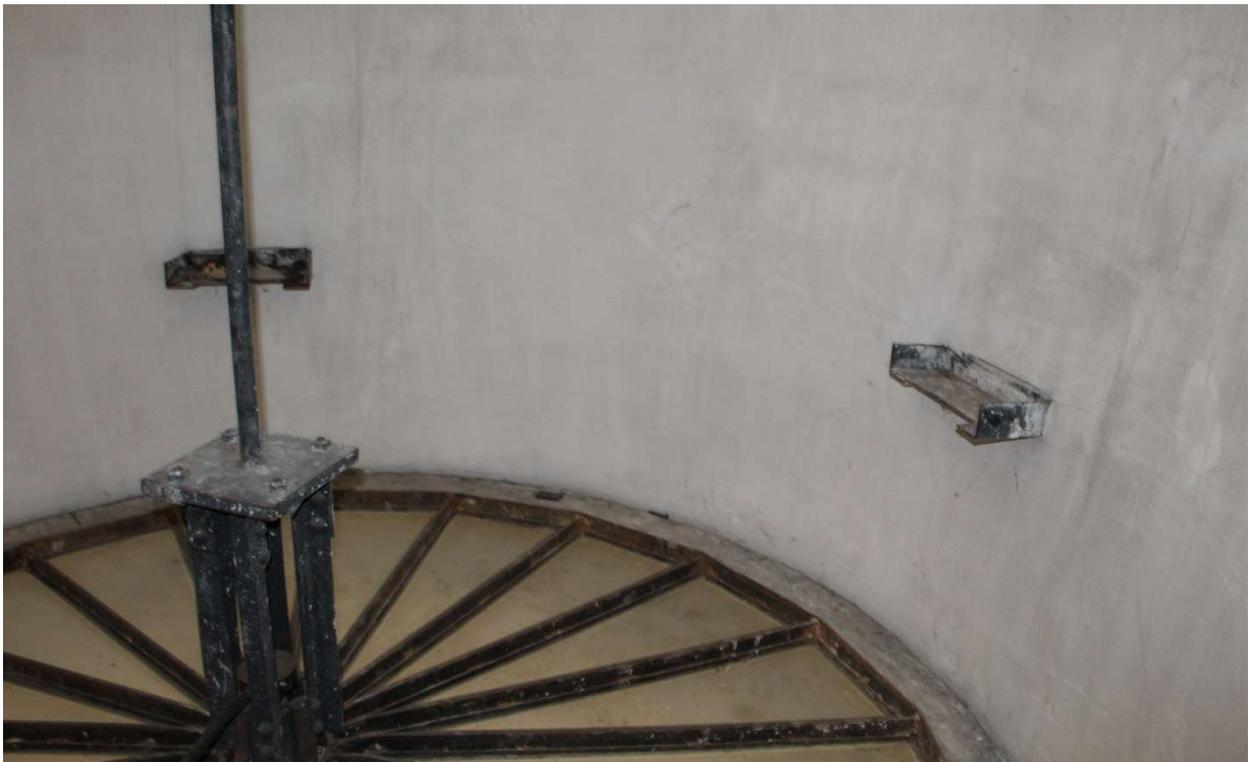
Figure 2. Wall brackets and central hub above laylight.

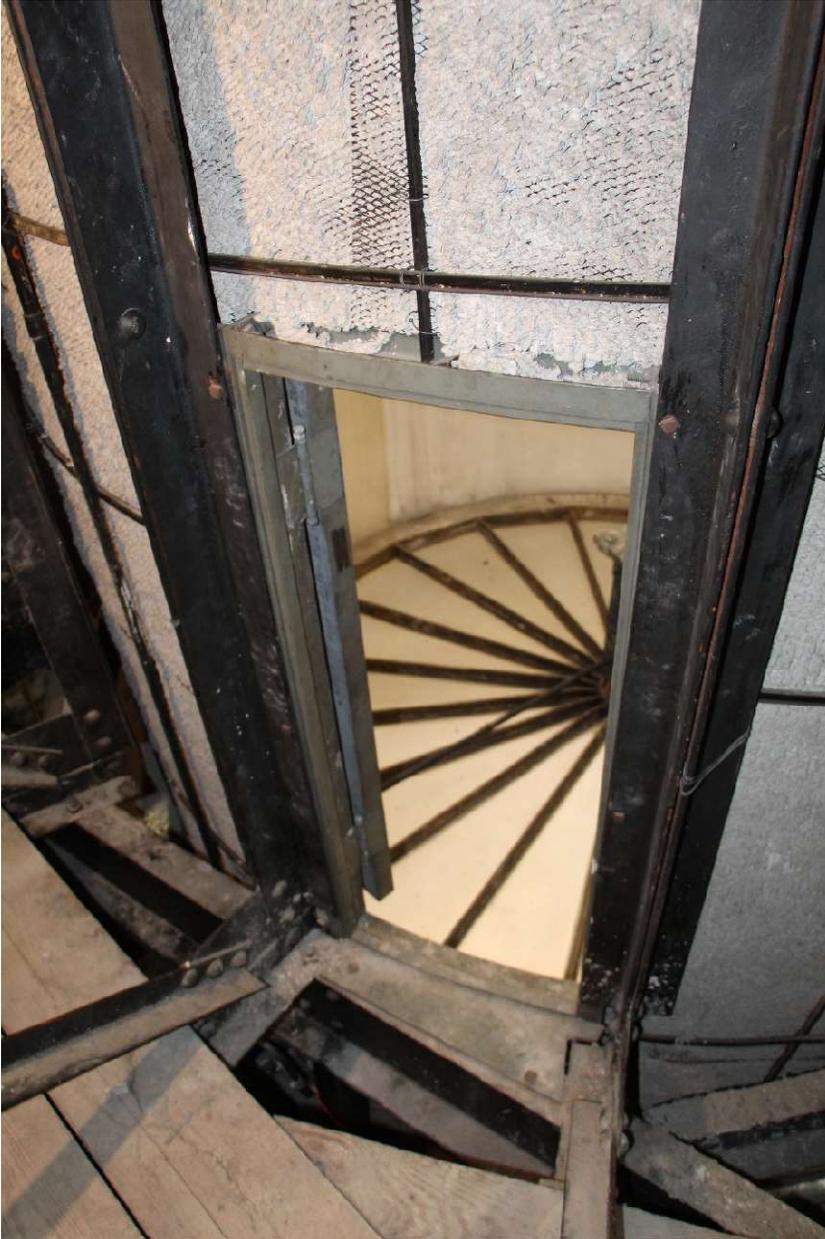
Figure 3. Access door from attic into laylight area.

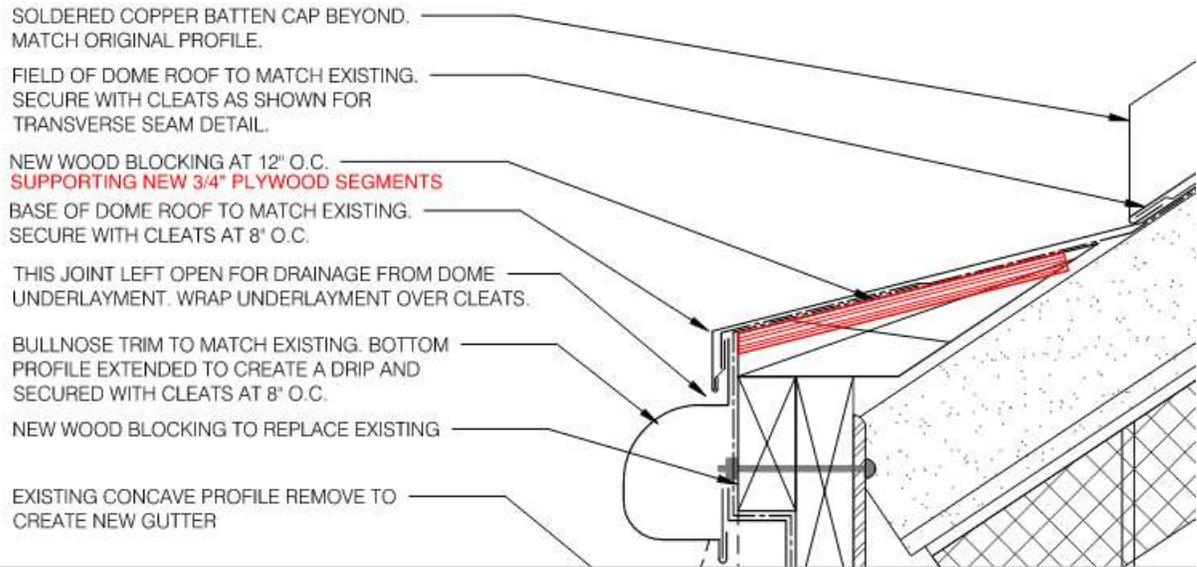
+6Refer to detail 5/A501

- A. SK-1, updated detail 3/A501.
- B. One annotation for detail 5/A501.
- C. Three photographs, for reference.
- D. Copper Development Association (CDA) detail 8.1B from *Copper in Architecture Design Handbook*, for reference.
- E. CDA detail 8.3G, for reference.
- F. Catalog cut sheet, for reference, from "Robertson Glazing Construction for Industrial and Commercial Buildings," H. H. Robertson Co., Pittsburgh, PA, 1925.

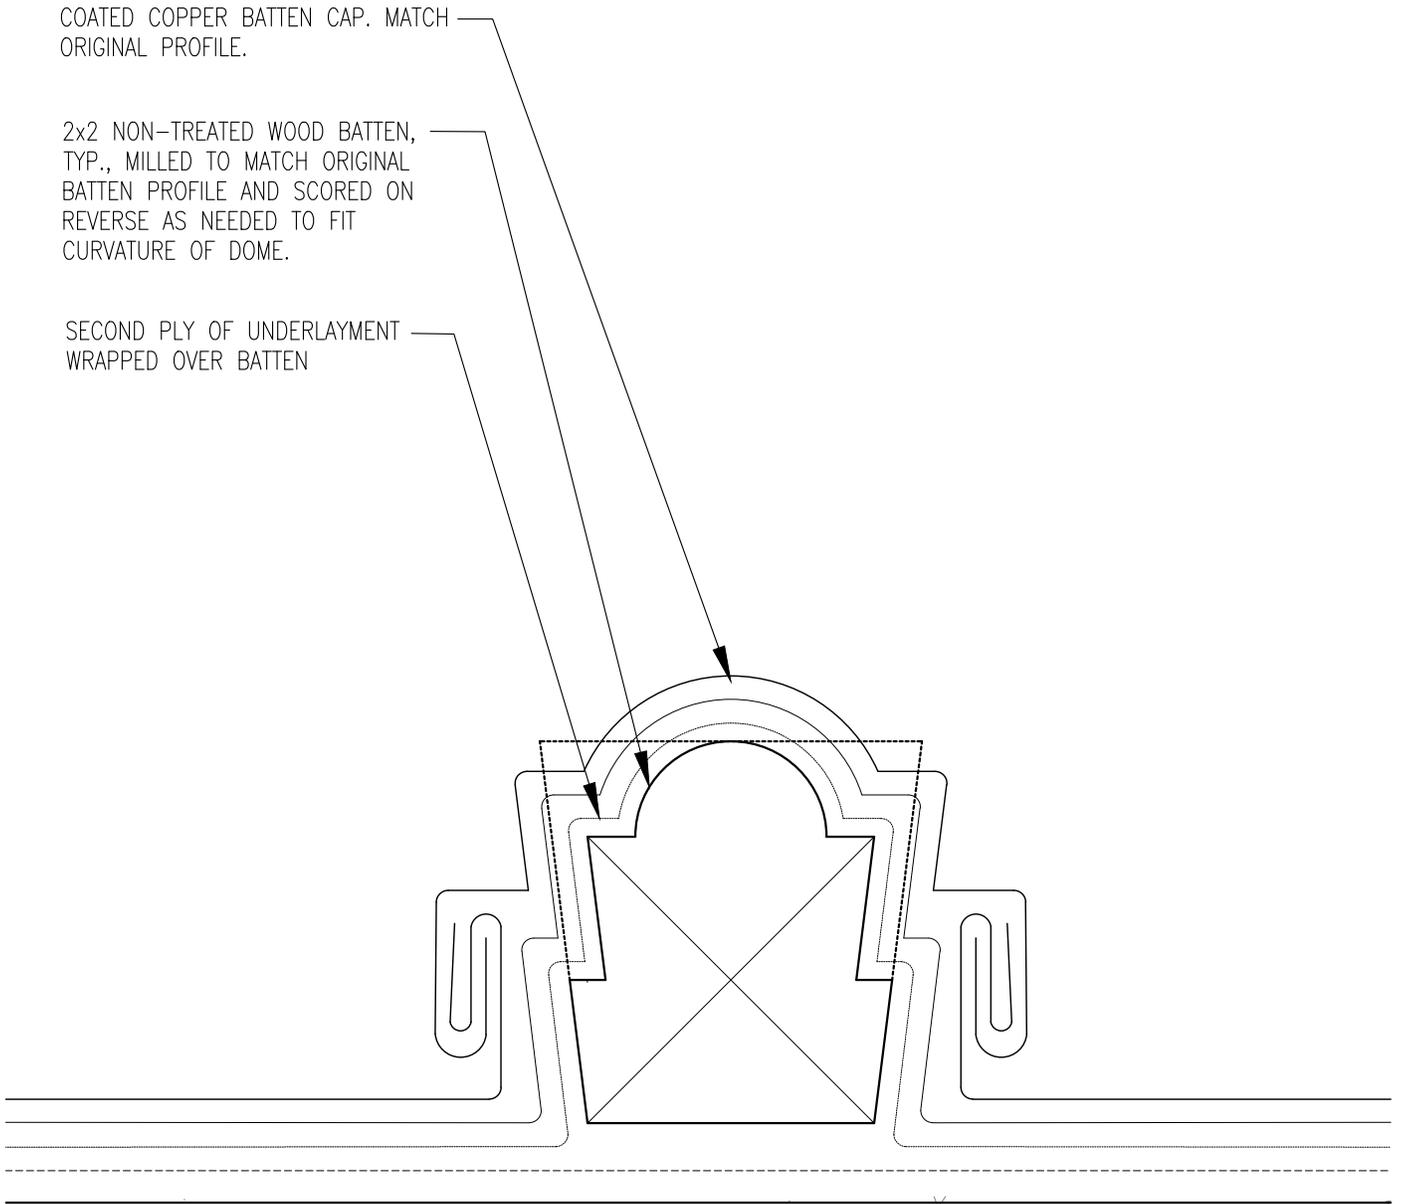
**SK-1**

COATED COPPER BATTEN CAP. MATCH ORIGINAL PROFILE.

2x2 NON-TREATED WOOD BATTEN, TYP., MILLED TO MATCH ORIGINAL BATTEN PROFILE AND SCORED ON REVERSE AS NEEDED TO FIT CURVATURE OF DOME.

SECOND PLY OF UNDERLAYMENT WRAPPED OVER BATTEN

Ref. Detail 3/A501

- B. Question: It is difficult to visualize the decorative profile of the batten covers from the photographs. Can detail 3/A501 be updated?
1. Answer: Refer to SK-1, depicting the typical batten geometry; exact dimensions to be verified in the field.

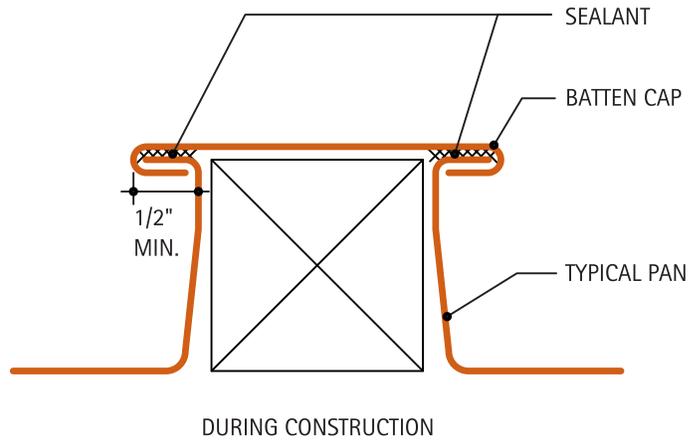
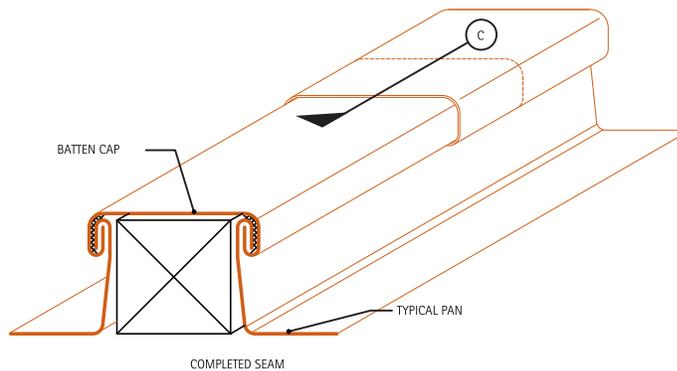
### 8.1B. Batten Seams

A compatible quality rubber or synthetic based sealant should be applied to the top flange of each pan prior to installation of the batten cap.

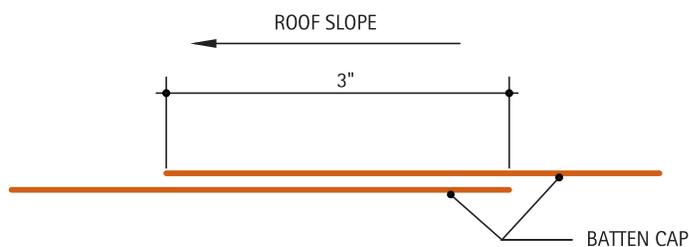
### 8.1C. Batten Cap

Where batten caps join, a 3" lapped seam is required

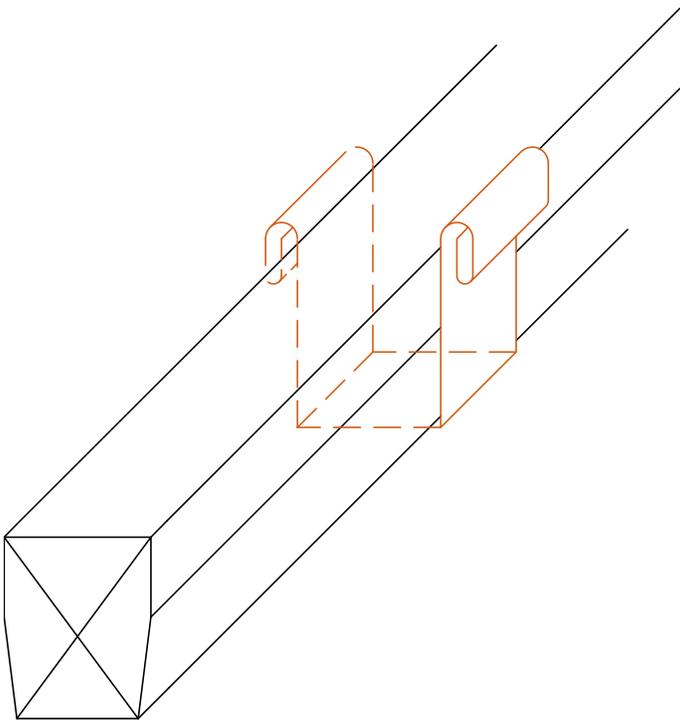
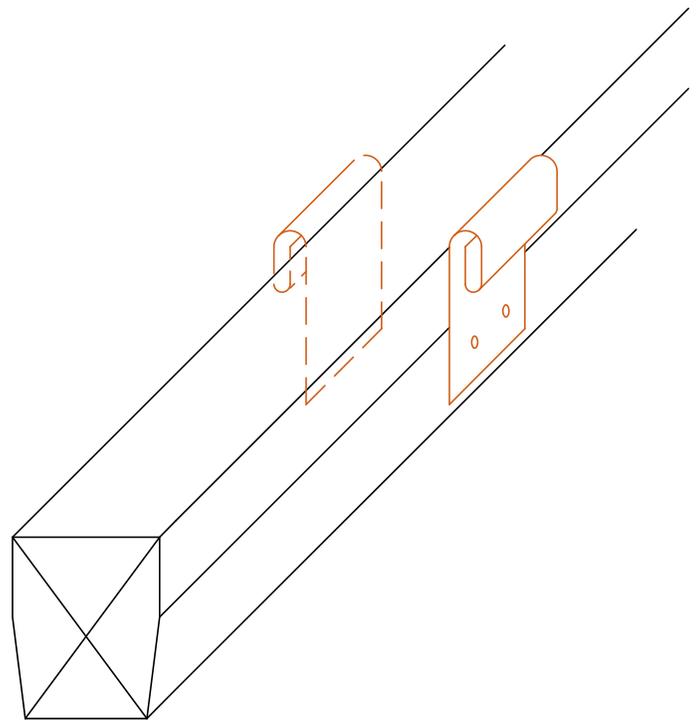
### 8.3G. Alternate Cleat Types

These types of cleats may be used with batten seam roofs. The type shown on the left must be placed during batten installation. The type on the right is attached to the installed battens with copper nails before or after batten installation.

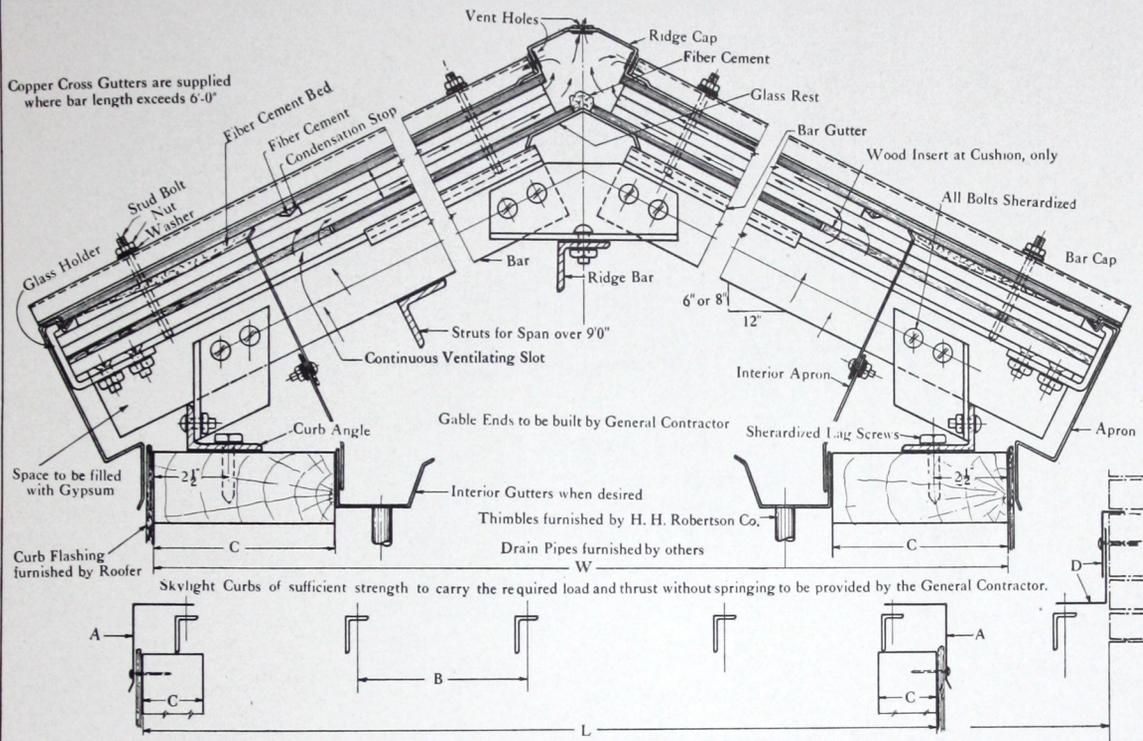
ROBERTSON DOUBLE GLAZED DOUBLE PITCH SKYLIGHT

- A—Flashing over curb.
- B—Bar spacings 18 $\frac{3}{4}$ " and 20 $\frac{3}{4}$ ". These spacings take respectively 18" and 20" glass.
- D—Flashing and counter flashing where skylight butts against wall.
